National Aeronautics and Space Administration

# **Nuclear Compton Telescope Balloon Launch in Alice Springs, Northern Territory, Australia High Visibility Type B Mishap IRIS Case Number S–2010–119–00007 Volume I of II**

**Date of Mishap: April 29, 2010**

**Date of Report: September 7, 2010**

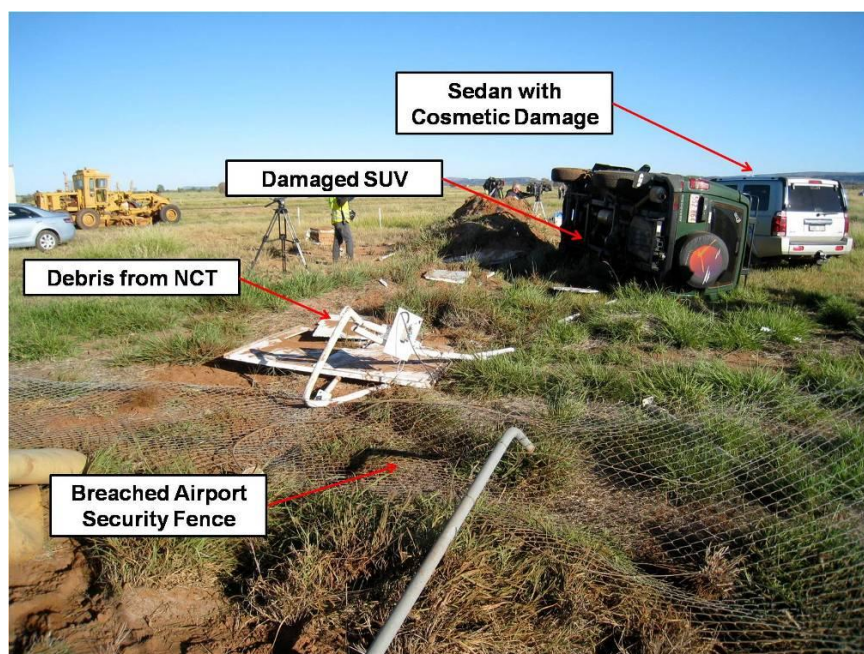
Figure 27. Damaged Vehicles and Airport Fence

**Key Event 47:** At PET=177 s the dragging payload hit a spectator's vehicle. At approximately the same time, the abort command was sent, releasing the balloon from the top of the parachute. After the balloon was separated from the parachute, the payload came to rest. Spectator locations at the time of impact and property damage are shown in Figures 26 and 27.

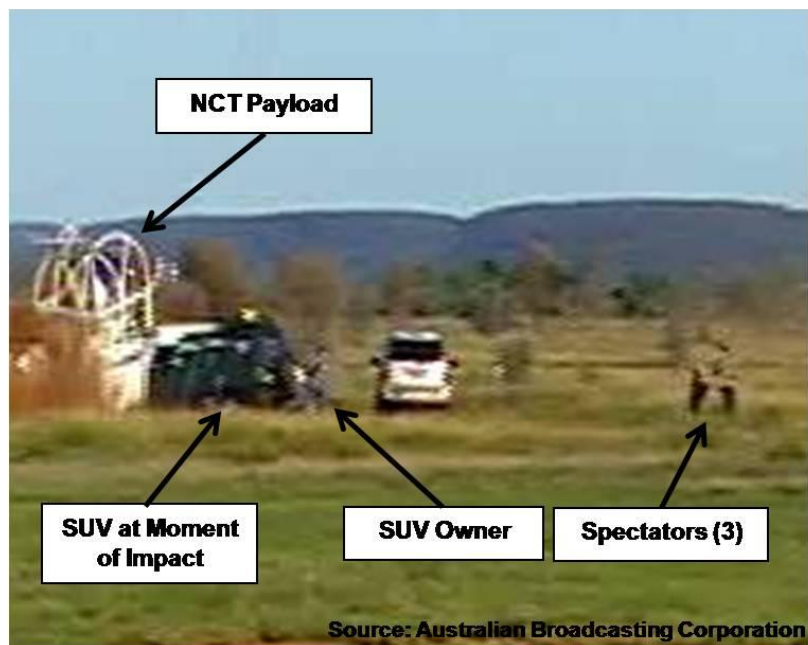
Figure 29. SUV Owner Running Just Before the SUV Was Impacted

Immediately after the payload came to rest, spectators checked on the health of each other and all were found to be uninjured. The spectator that was on top of the impacted vehicle saw the danger and ran to protect himself as shown in Figure 29.

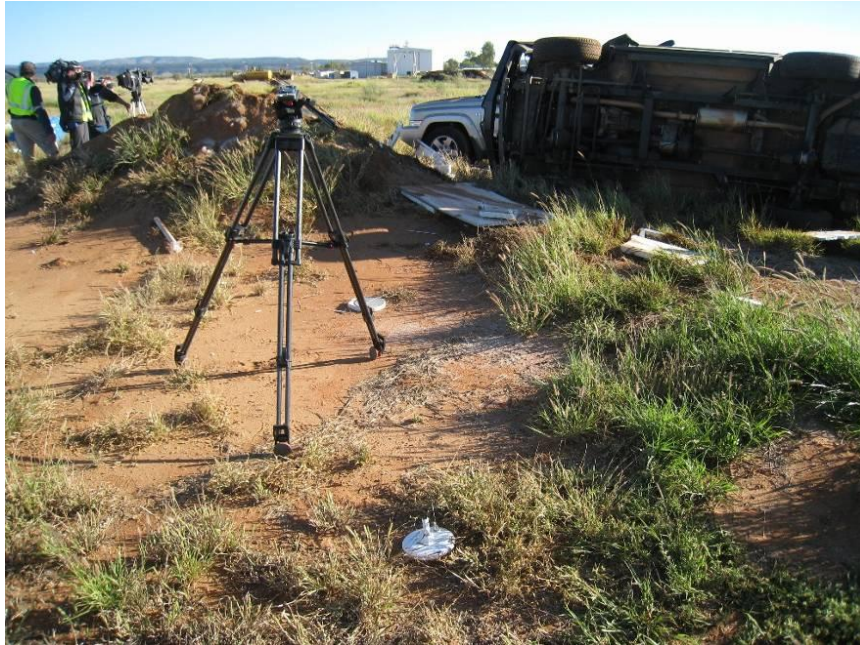
**Figure 30. Camera Crew and Spectators After the Mishap**

The vehicle near the impacted vehicle had two spectators inside. This vehicle suffered cosmetic damage. Within 30 seconds after the event, spectators and camera crew had approached the damaged payload shown in Figure 30.

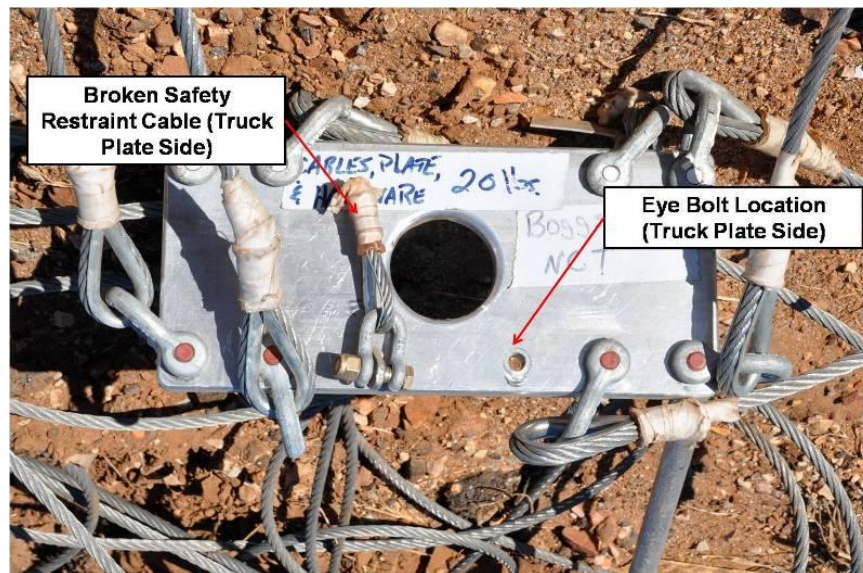
Figure 32. Truck Plate as Photographed at the at Mishap Site

During the course of the investigation into the Nuclear Compton Telescope Balloon Launch Mishap, the MIB collected data and reviewed 18 witness statements that were taken by CSBF management prior to the MIB's arrival in Alice Springs. The MIB photographed evidence at the mishap site and obtained aerial photographic records of the mishap site. Photographs of the broken safety restraint cables are shown in Figures 32 and 33. The MIB conducted a total of 21 witness interviews. In addition, the MIB reviewed balloon launch operation procedures, equipment certifications, past balloon anomaly reports, equipment drawings, personnel certification training records, range and ground safety requirements, video and photographic evidence, and physical evidence. The MIB also performed strength testing on safety restraint cables that were manufactured as test samples for the board.

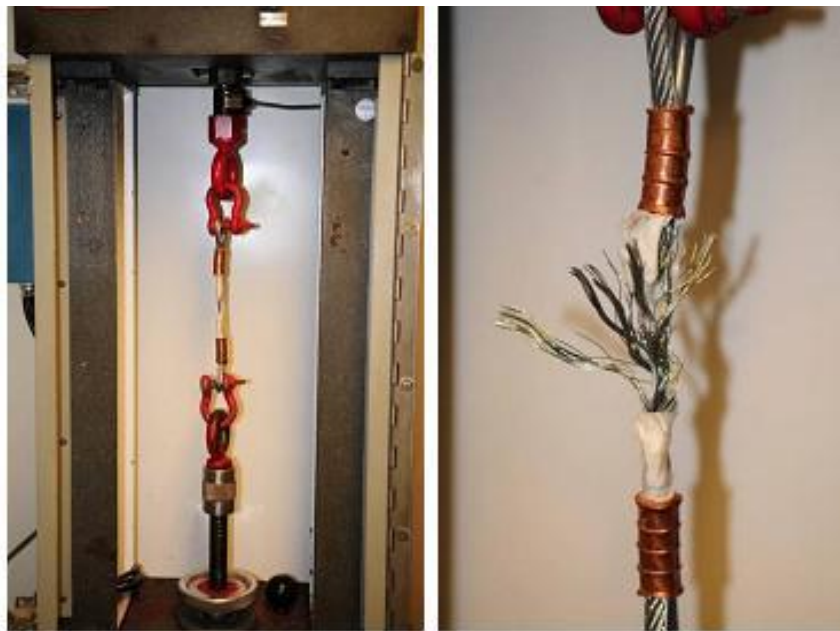
**Figure 38: Safety Restraint Cable Strength Test Configuration**

**Summary of Test**—A simple destructive pull test was performed at WFF on safety restraint cable sets similar to those used for the NCT launch attempt to determine the actual break strength of the safety restraint cables. The cable sets were supplied by the CSBF. Two break tests were performed showing the breaking strength to be 8,000 (+/- 20) lb. Figure 38 shows the test setup.

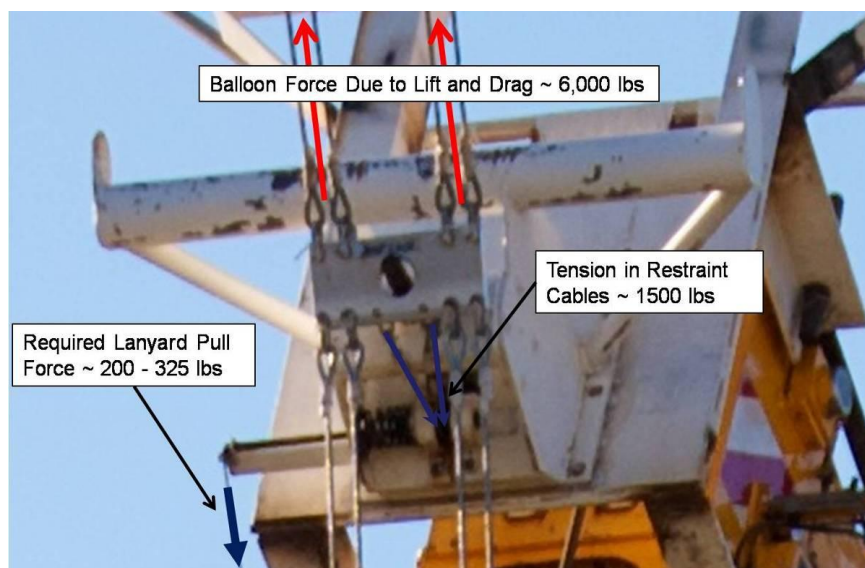
**Figure 40. Forces on Launch System at Launch Attempt Created an Unviable Condition**

Using the data from Field Test 1, the resulting lanyard pull force would be predicted to be in excess of 300 lb (test data only covered up to 1400 lb suspended). Predicted loads on the launch mechanism and the resulting required lanyard pull force at the time of the launch attempt are shown in Figures 40 and 41.

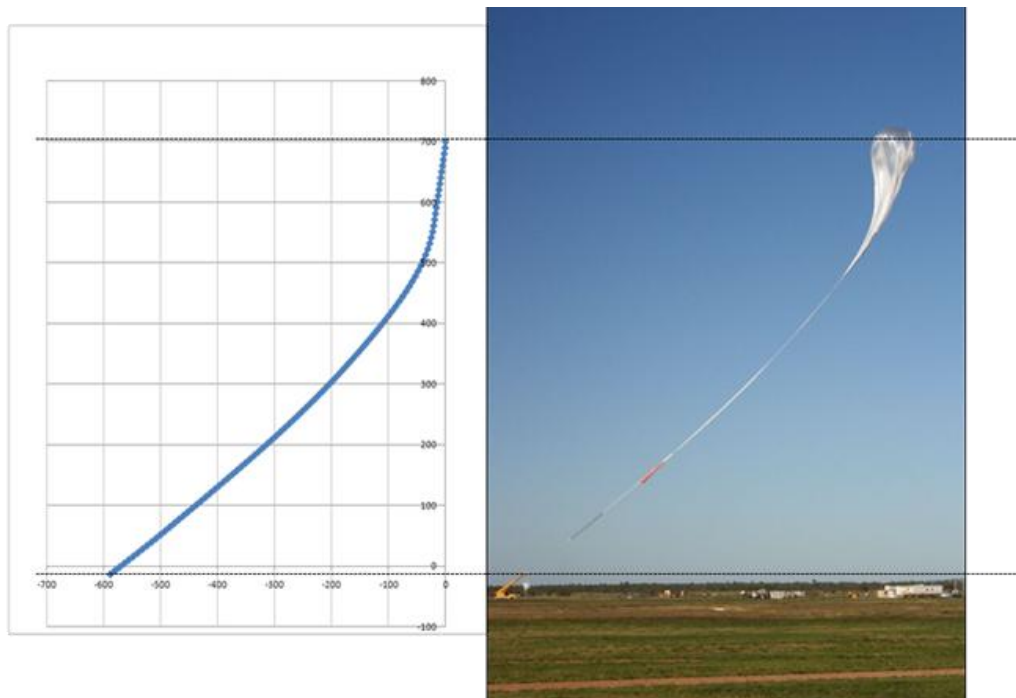
**Figure 42. Static Catenary Assessment**

The catenary Steady State Equilibrium analysis solution produced a good geometric fit with the photographic evidence as shown in Figure 42 when the launch vehicle was stopped at the Airport fence. The necessary forces at the truck plate to support the system weight and drag through the catenary were calculated to be approximately 9350 lb at approximately 38 degrees from horizontal. The associated horizontal drag force component was approximately 7300 lb.

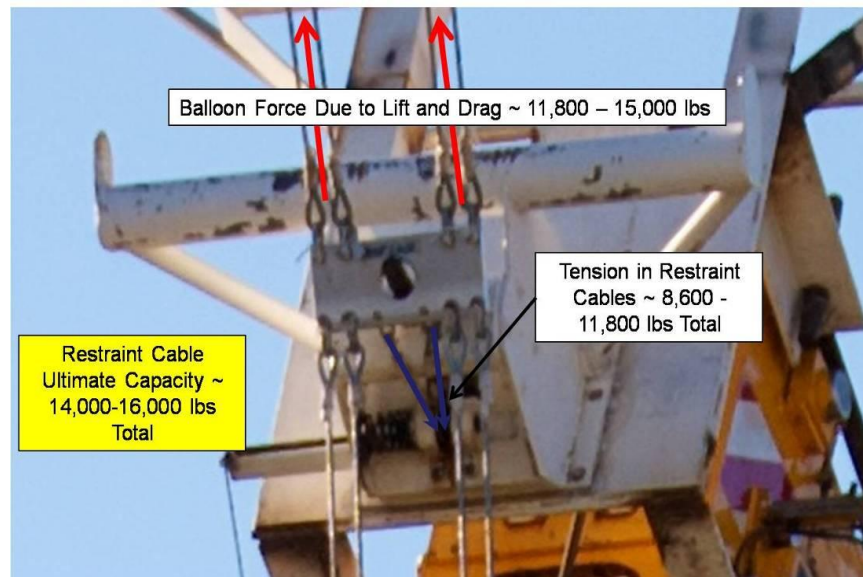
**Figure 43. Forces on Launch System During Backing Maneuver  
Created Unsafe Operating Condition**

**Analysis Finding: The safety restraint cables were used in a backing operation that the cables were not designed to perform. The implemented factor of safety was approximately 1.3, which is inadequate for this operation.**

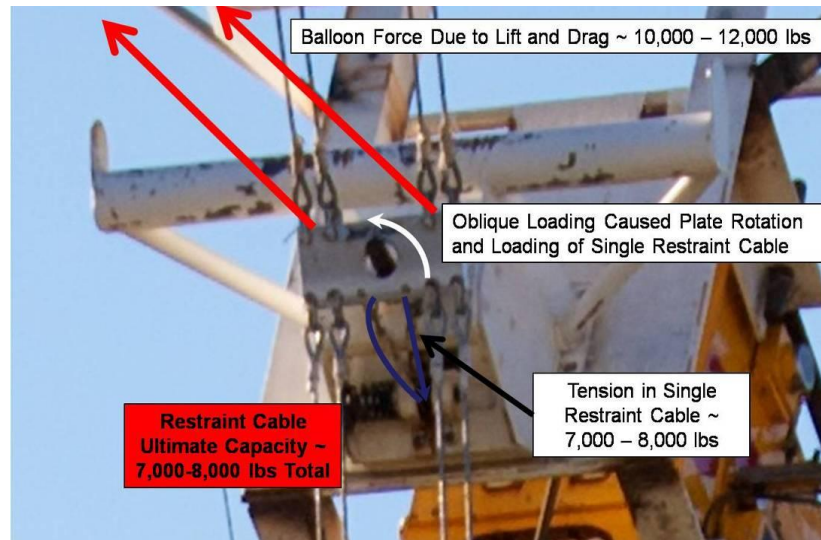
**Figure 45. Forces on Launch System During Turning Maneuver Resulted in Cable Rupture (Note that there was no face-on photograph of the hardware at the time of rupture.)**

During the left turn maneuver of the launch crane, one restraint cable became off-loaded. The remaining restraint cable reacted the loads from the wind-driven balloon, which exceeded the cable's ultimate strength capability. One restraint cable ruptured, causing the unloaded cable to pick up the load. The second cable assembly also broke due to the loading condition. The load conditions and predictions of hardware behavior are consistent with hardware evidence collected in the field at Alice Springs.
